# Act of Redemption

**An aerobic treatment unit and seldom-used trench bed prevents a widow's home from being condemned in northern Georgia**

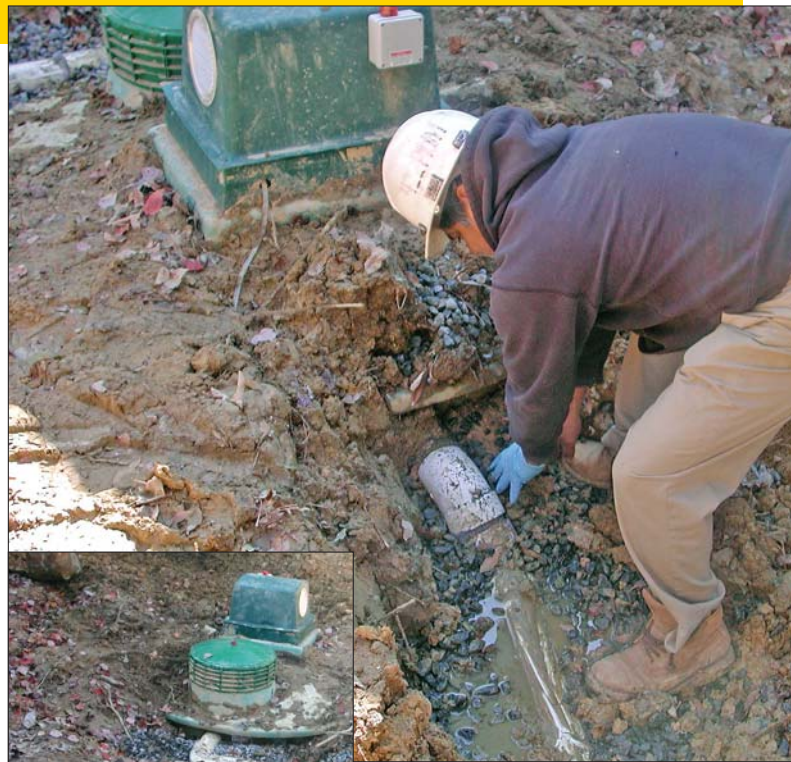
**Above, Juan Gonzalas clears soil from around the pipe to check the connection to the Aqua Safe treatment unit. At left, the septic tank riser appears in the foreground; then the riser on the Aqua Safe pretreatment unit and its control, housing the air compressor and electrical components. (Photos courtesy of Superior Plumbing)**

Using a mini-excavator from IHI Compact Excavator Sales with 36-inch bucket and 360-degree swing, they dug the hole for the aerobic tank 4 feet from the septic tank, and gave the 4-inch PVC pipe connecting the two a 4-inch fall.

A control box on the ATU’s tank top housed the air compressor and electrical components. The riser on the tank has a 4.75-inch inspection port. While both tanks were being set, the excavator operator dug the 20- by 75-foot drainfield pit 18 inches deep, excavating from one end to avoid compacting the soils.

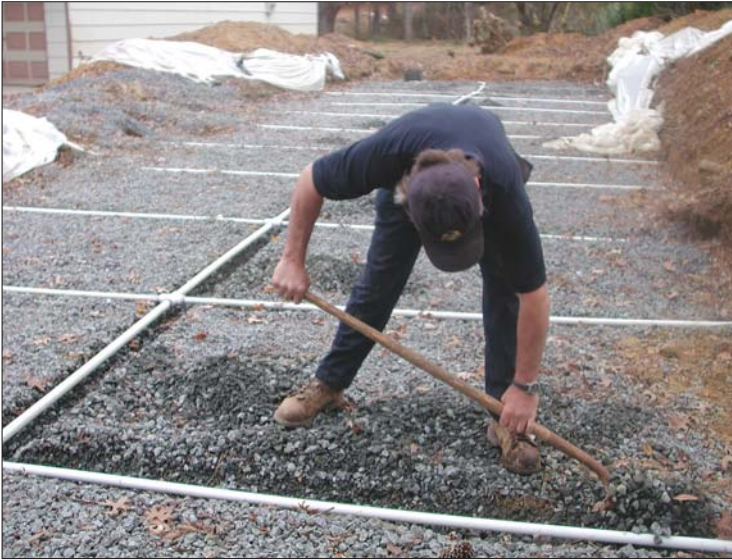
**Wes Lamb uses a trenching shovel to prepare for burial of the distribution pipes.**

Barnhardt completely tested and inspected the system before trenching of the lines began. Using a trenching shovel, Wes Lamb dug down 3 inches. “We’d get our depth, set a section of pipe, cover it with 2 inches of gravel, and repeat the process,” says Law. “The work took half a day to complete, and that’s where you start getting into cost because this was a big pit.”

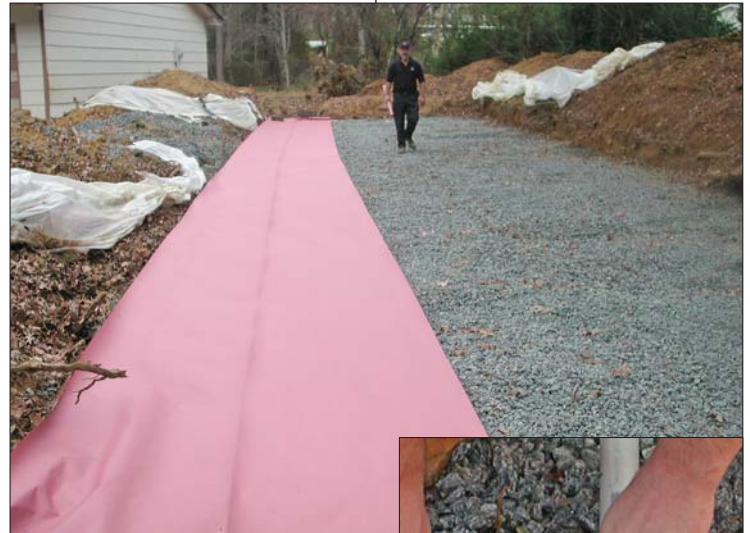
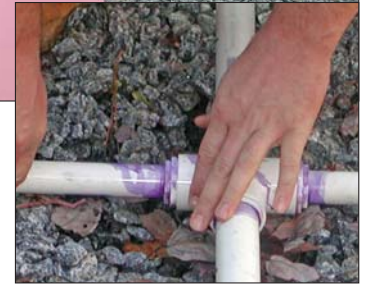
**Above, Wes Lamb covers the low-pressure bed with contractor’s paper to keep out dust and dirt. At right, a technician cements 10-foot-long, 1-inch laterals to the 1.25-inch main trunk line in the low-pressure bed.**

Twelve inches of prewashed 57 stone was deposited into the graded pit and raked level by hand. On top of that went 275 feet of PVC pipes cemented together. The 1.25-inch main trunk line ran down the center of the pit. On either side were 10-foot-long, 1-inch laterals on 5-foot centers. Five 1/4-inch drip emitters were equally spaced along each lateral with the third hole at the junction

After Barnhardt inspected the disposal bed, Lamb laid contractor’s paper over the gravel to keep dust and dirt from contaminating it. That night brought a downpour. Law knew the site would be a mudslide and dreaded going back. “By luck, the gravel bed was as clean as when we installed it,” he says. “I was real thankful that I didn’t have to start all over again.”

of the trunk line. Hand-drilled drip emitters faced down.
